Contract #: 04-0120F4Cty: SF/ALA Rte: 80 PM: 13.2/13.9File #: 69.28**WELDING INSPECTION REPORT****Resident Engineer:**Siegenthaler, Peter**Address:** 333 Burma Road**City:** Oakland, CA 94607**Report No:** WIR-022367**Date Inspected:** 26-Mar-2011**Project Name:** SAS Superstructure**OSM Arrival Time:** 1500**Prime Contractor:** American Bridge/Fluor Enterprises, a JV**OSM Departure Time:** 300**Contractor:** Zhenhua Port Machinery Company, Ltd (ZPMC), Changxing Island **Location:** Shanghai, China

Bridge No: 34-0006**Component:** OBG Segment Assembly**Summary of Items Observed:**

WELDING INSPECTION REPORT

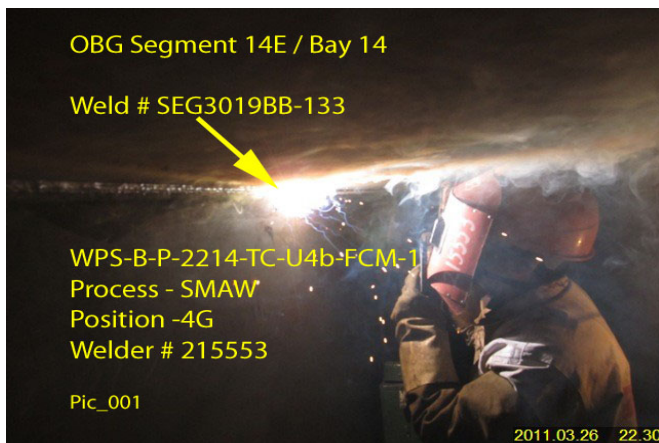
OBG Segment 14E / Bay 14

Shielded Metal Arc Welding (SMAW) in the 4G position of SA to AP weld # SEG3019BB-177. The welder is identified as 054013. Quality Control (QC) is identified as Xie Ming Feng. The welding variables recorded by QC appeared to comply with WPS-B-P-2214-TC-U4b-FCM-1.
